**Full Performance Evaluation**

**The Division of  
Culture and History**

**There is a Risk of Loss to the Archives and Museum  
Collections Due To Inadequate Storage  
and Insufficient Fire Protection**

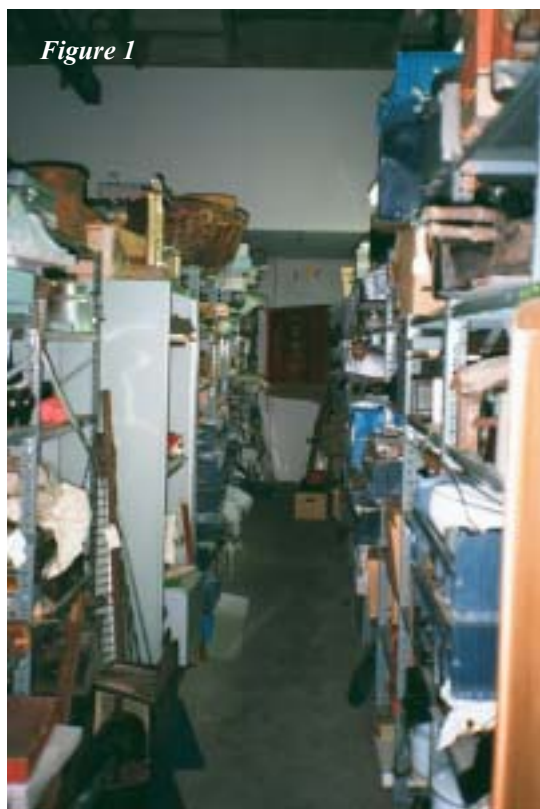
Figure 1

*Museum Artifacts Storage Area* - The museum artifacts storage area is used to store items such as furniture, guns, dishes, clothing or paintings etc., which have historic value to the State or represent items used during

*Left: Museum Artifacts Storage Area*

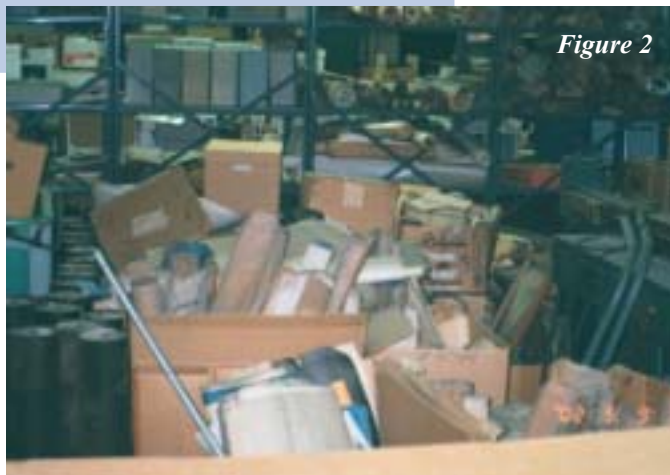
Figure 2

*Below: Archives Storage Area*

*The Legislative Auditor found the archives storage area, which encompasses 23,445 square feet to be cluttered and disorganized.*

*Archives Storage Area* - The archives storage area is used to store documents, records, books, or other historic papers, which have historic value to the State. The Legislative Auditor found the archives storage area, which encompasses 23,445 square feet of space within the Cultural Center, to be cluttered and disorganized. In addition, there is a backlog of documents exhibiting signs of deterioration while awaiting microfilm preservation. Archives officials estimate that it will take over 12,000 hours to complete processing only a *portion* of archival materials. If one staff member were to work 40 hours per week on processing only, and presuming no *new* archival materials are added, the task of microfilming would be completed in August 2007.

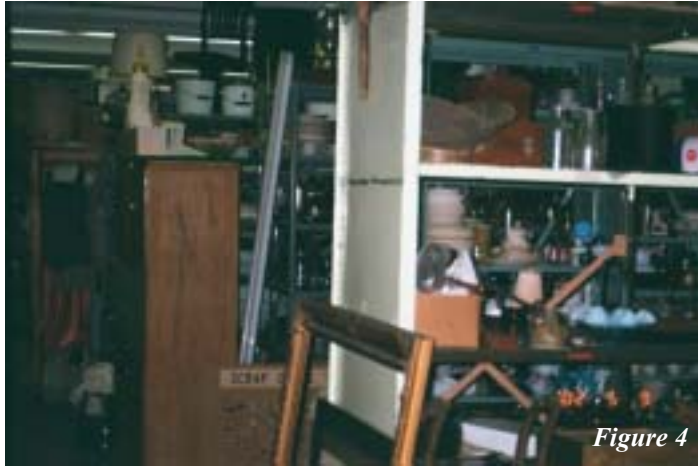
*Figure 4*

*Above Left and at Right:  
DCH Loose Artifact Storage*

- i **Stacking.** Due to the cramped conditions, and lack of a professional space storage system, the staff is forced to store some artifacts by stacking, resulting in possible damage to items from friction, weight or

possible breakage from falling. The storage areas also present safety hazards because walkways have items stacked on the floor. Staff carefully handle and place items in storage, but damage to artifacts could occur as staff attempt to navigate through the narrow areas. It is possible that artifacts could fall off the high, open shelves.

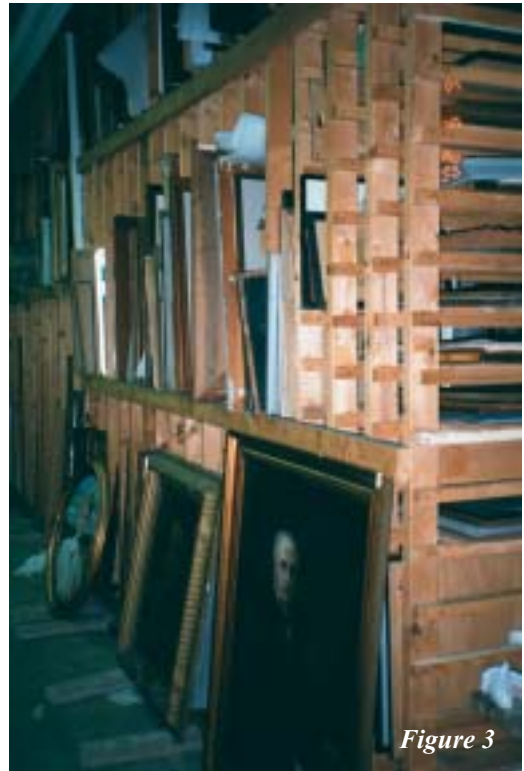
*Figure 3*

*Above Right: DCH Painting Storage*

*Paintings and frames have also been damaged from the position of storage on wooden storage racks.*

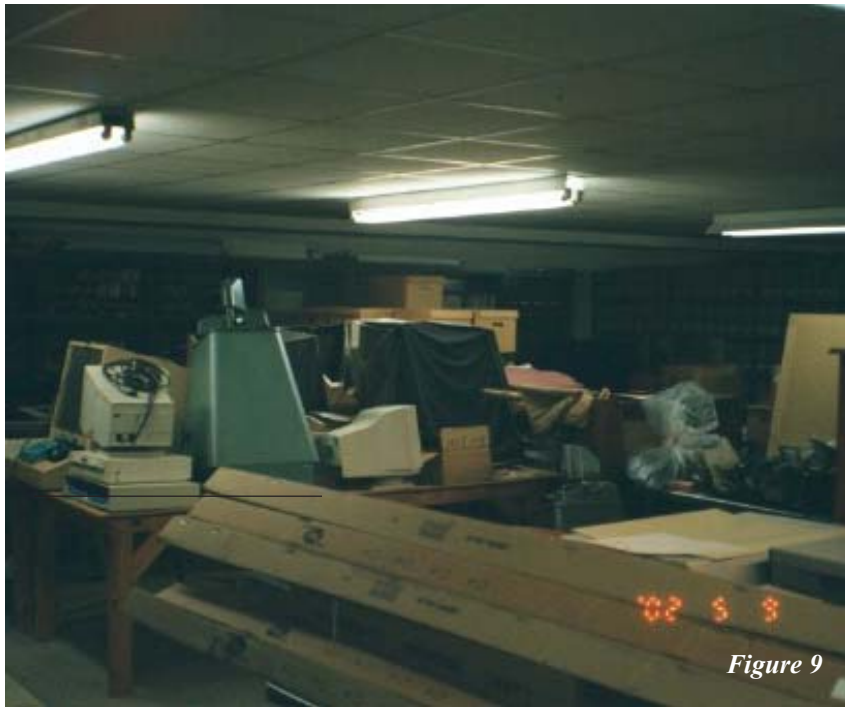
Figure 9

*The initial tours of the archives storage and work areas found cluttered, disorganized library stack areas housing archival materials with many non-archival items, such as old chairs and desks, antiquated and out-dated equipment.*

- i **Storage.** The initial tours of the archives storage and work areas found cluttered, disorganized library stack areas housing archival materials with many non-archival items, such as old chairs and desks, antiquated and out-dated equipment. Since then, the agency has made some improvements that include removing non-archival items to surplus property, building shelving and creating work spaces. However, many special collections waiting to be processed were stored in cramped spaces, on the floor, in mis-matching wooden shelving and lying loose or open, vulnerable to light, dust, mold and mildew. See pictures of the archives storage area on the following page.
- i **Mold/Mildew.** Audit staff observed items which appeared to have mold or mildew on them located next to uninfected archival materials.

## WVDCH Archives Storage Area

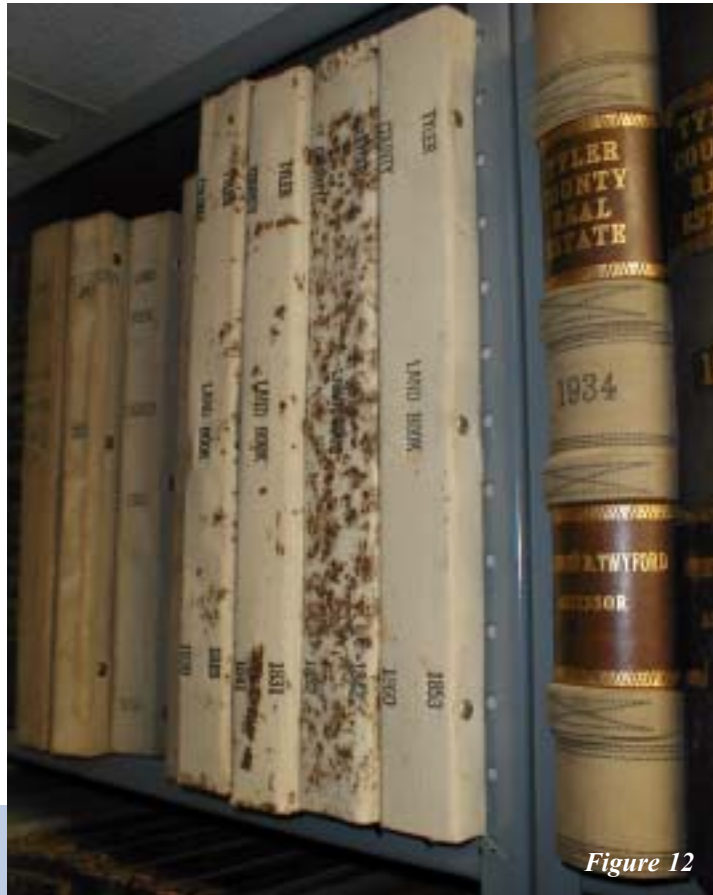
*Figure 12*

## Mold or Mildew on Books in WVDCH Archives Storage

*Audit staff observed items that appeared to have mold or mildew on them located next to uninfected archival materials. According to national standards, archival materials infected with active mold or mildew should be isolated from other items and cleaned to prevent the spread of these conditions.*

According to national standards, archival materials infected with active mold or mildew should be isolated from other items and cleaned to prevent the spread of these conditions. A new HVAC system for the Cultural Center building now controls humidity. This has probably limited the active development of these conditions. However, should something happen to the HVAC system, these conditions could become active again and infect more archival materials. This problem should be assessed by an expert to determine if it is mold or mildew, whether it is of a type to be hazardous to human health, and if it is active. The materials should be properly cleaned. See photographs of the mold or mildew on books contained in the archives storage area on the preceding page.

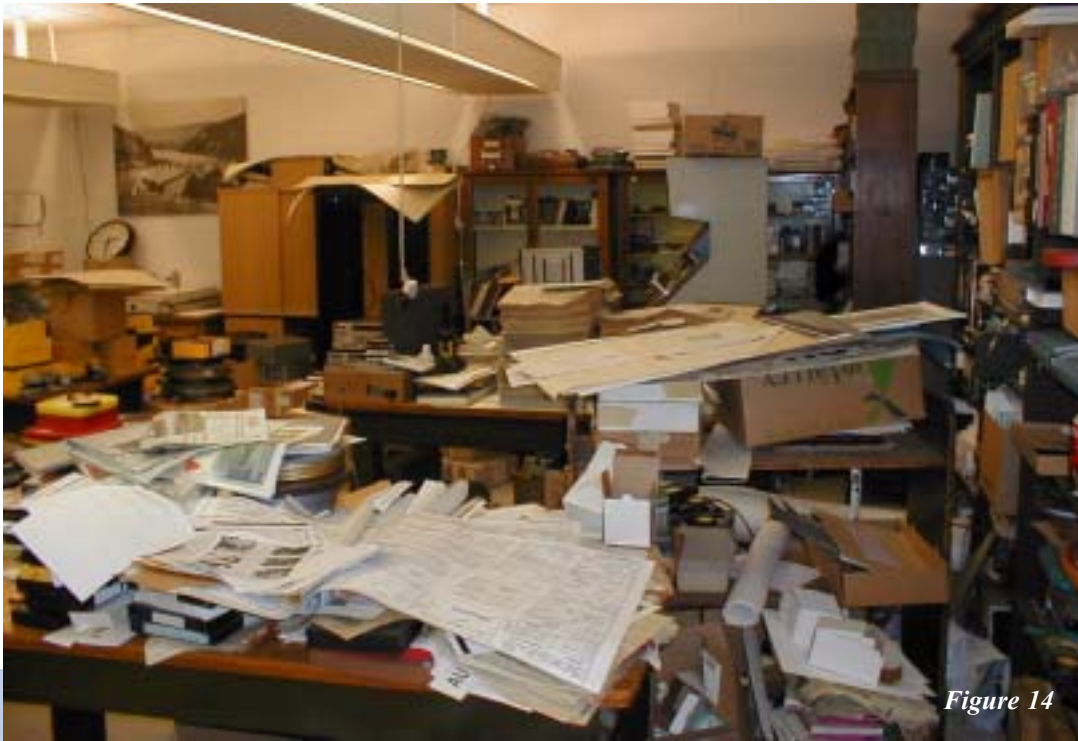
*Figure 14*

In addition to the risks of loss from fire and damage from current storage conditions, risks exist from the loss of items due to disorganization and internal theft. **Experts in cultural property storage indicate that administrative loss, which includes storage disorganization and internal theft, is the most common cause of loss to cultural property.** During a tour of the facility, the Legislative Auditor noted that several areas of the facility were very disorganized. Specifically, the Archives audiovisual processing area, which processes photos, microfilms documents and archives films had many unorganized stacks throughout the room. **This area is extremely cluttered and disorganized.** Staff may be meticulous in their work, but items can easily become lost or damaged in such clutter. See pictures of the graphics processing area on the following page.

## WVDCH Graphics Processing Area
