January 2022
PE 21-16-650

SPECIAL REPORT
REVIEW OF THE STATE'S LABORATORY FACILITIES

**State Laboratory Testing Facilities' Needs and
Issues Are at Critical Points**

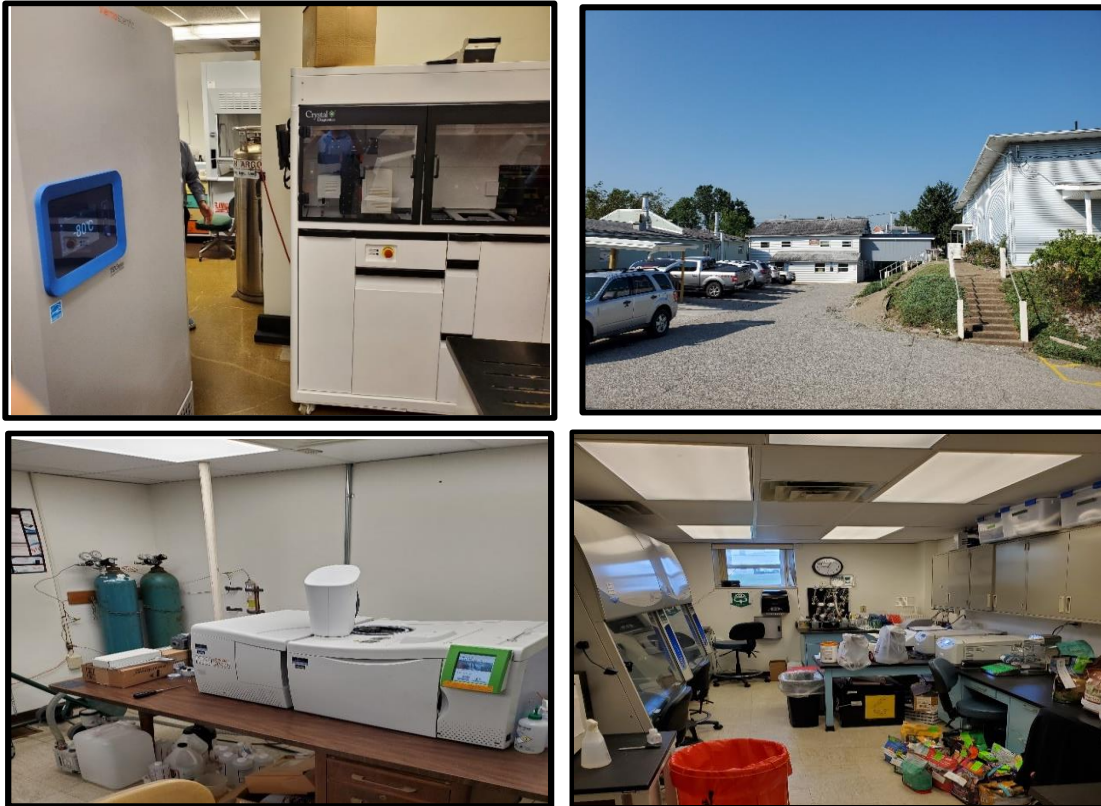
Figure 1
Department of Agriculture Laboratories at the
Gus R. Douglass Agriculture Complex, Guthrie, WV

Agriculture’s laboratories suffer from being in old buildings, not designed to be laboratories. The Gus R. Douglas Agriculture Center in Guthrie was built as a Cold War Air Force base, and later was donated to the State. The buildings that house the labs were originally designed as offices, and part of the READ building was a gymnasium.

All of Agriculture’s labs are running out of space to house equipment and provide adequate workspace for employees. As the pictures above show, workbenches are crowded with equipment and the agency has had to utilize old office furniture to place equipment on. Also, the lack of space and layout of the buildings requires samples to be carried from room to room to go from preparation to testing, as the layout is not conducive to the workflows of the labs. The agency also recently purchased a piece of equipment for testing for foodborne pathogens. As shown in Figure 1 below, the machine is catty-corner to a freezer in the Dairy lab and there is barely enough space between the two appliances for a person to walk through. The agency would like to add a Level-3 Biological Safety Lab (BLS-III) to the READ labs but lacks the space. Even if the space was

Decade Built:	1950s	Lab-purposed?	No
Secure Perimeter?	Yes	Adequate Space?	No
Testing Programs:	Animal Disease Diagnostic Tests, Pest Identification, Cooperative Forest Health Protection Plant Pathology, Food, Commercial Feed, Environmental, and Water Microbiology, Dairy, Research & Development (Biothreats), Metals, Agricultural Materials, Seed, Pesticides and Residues, and Hemp/Cannabis

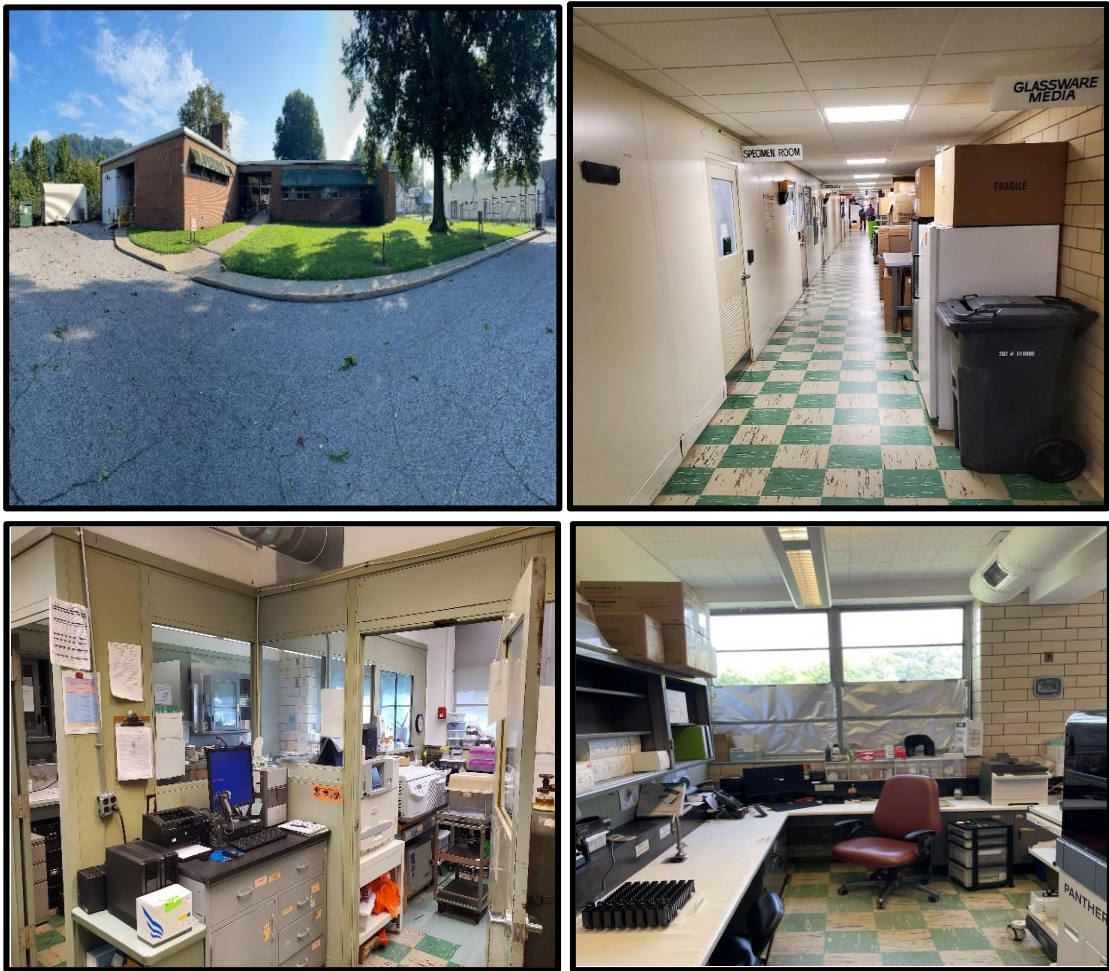
Figure 2
The Department of Health and Human Resources,
Public Health Laboratory in South Charleston, West Virginia

Figure 2 shows the Public Health lab facility that is located in South Charleston. The age and location of the Public Health Lab has created several problems for OLS. Built in 1954, the Bureau of Public Health's Laboratory is the second oldest public health laboratory facility in the United States. The building has had few renovations over the years which has allowed the building to become dated. The major components (e.g. the floors, windows, plumbing fixtures) are original to the building's construction. For instance, asbestos is an issue throughout the building. It has been found under the sinks and in the window insulation in the labs as well as in the subflooring under the tiles.

Lack of space is also a significant concern. The Newborn Screening Lab and Environmental Chemistry Lab were relocated due to lack of space. The Newborn lab was moved to the West Virginia Regional Technology Park and the Environmental Chemistry Lab was moved to Big Chimney, West Virginia. The lab director informed PERD's staff that the agency cannot hire the necessary number of staff in certain areas because there is no workspace available. The lack of space also affects testing procedures. For instance, the microbiology lab's testing equipment and sample prep areas are co-located in the same room but should be separate to avoid contamination of samples. However, the agency does not have enough space to put them in separate rooms.

Year Built:	1954	Lab-purposed?	Yes
Secure Perimeter?	Yes	Adequate Space?	No
Testing Programs:	Diagnostic Immunology, Environmental Microbiology, Microbiology, and Threat Preparedness (Biological)

The Public Health Lab’s HVAC system is also antiquated which impacts the agency’s work. It is difficult to control ambient temperatures in the laboratory because the labs’ windows are single-paned and leak air. The agency has installed window AC units in many of the labs to help maintain the required ambient temperatures required for the testing equipment. In the

Chlamydia and Gonorrhea section of the Diagnostic Immunology Lab, the staff must use space heaters to maintain adequate temperatures to complete tests. The Tuberculous Laboratory was shut down in October 2020 because the HVAC's negative air pressure system could not be maintained due to gaps in the walls and ceiling. Replacing the hood would be costly and it cannot be repaired. Without the lab, OLS must send out test samples to a private laboratory. The private lab is slow in providing test results. Furthermore, the Tuberculous Lab is antiquated and not ideal for a Level III, Biological Safety Laboratory (BSL-III). The agency is considering options for replacing the lab, and it has received an expression of interest to develop plans for a new lab within the current building.

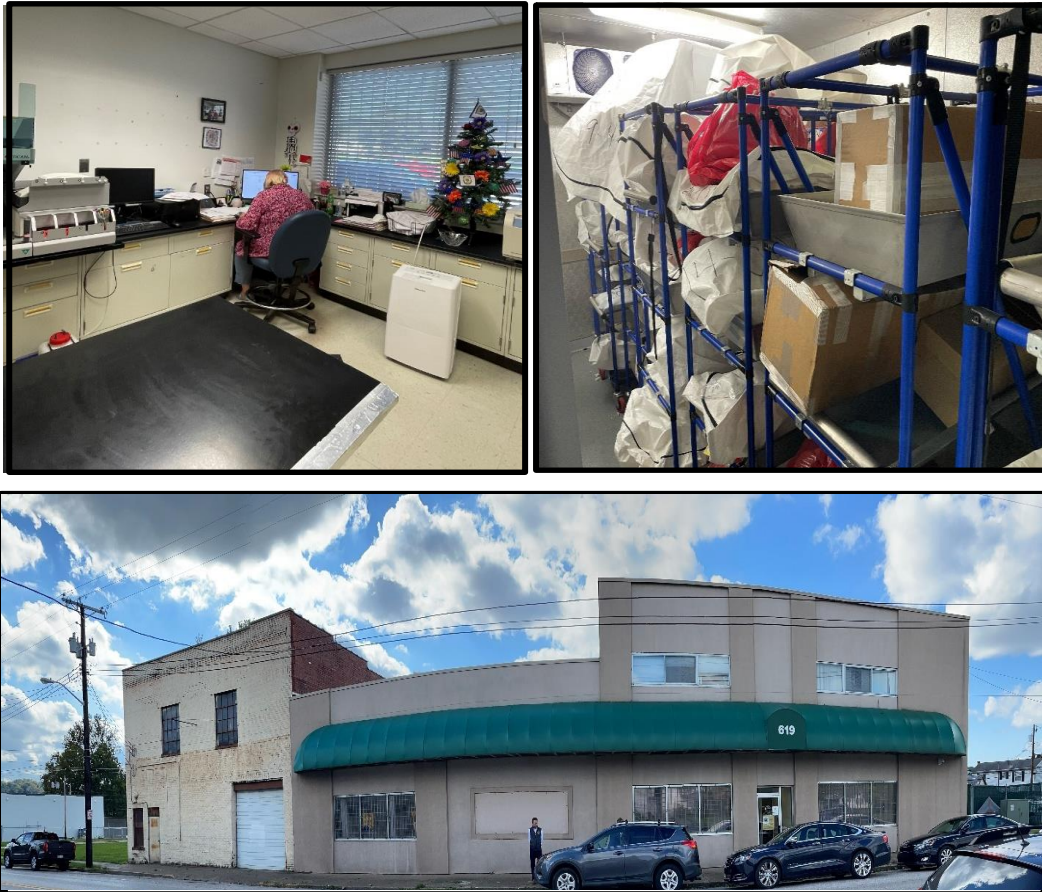
Figure 4
Office of the Chief Medical
Examiner Charleston, WV

Figure 4 shows the facility for the Office of the Chief Medical Examiner (Medical Examiner). The primary functions of the Medical Examiner are to perform death investigations, establish cause and manner of death, formulate conclusions, opinions, or testimony in judicial proceedings, and provide consultations as necessary. The Medical Examiner's facility includes an autopsy suite, where medicolegal autopsies are performed and a toxicology laboratory that supports the autopsy function in determining the presence of toxins that may have contributed to the cause of death.

Year Built:	1957	Lab-purposed?	No
Secure Perimeter?	No	Adequate Space?	No
Testing Programs:	Autopsy Suite and Toxicology (associated with autopsies)

The Medical Examiner’s facility is housed in an office building that required significant retrofitting to add the autopsy suite, cold storage to house decedent remains and toxicology laboratory. The size, configuration, and location of the building are all hinderances for the agency and its staff. The Medical Examiner is not currently accredited due to several issues associated with its facility. According to the agency, the issues include understaffing, and the autopsy suite is undersized for the number of autopsy cases it handles. The accreditation standard for case completion is 90 percent of cases completed within 90 days. Currently, the Medical Examiner’s average completion rate is 240 days which the agency attributes to a high caseload, the lack of

Based on the figures presented by the agency, the autopsy suite requires nine exam tables to meet the standard, but the current space only allows for two permanent exam tables and one "mobile" table. All sections of the agency are understaffed, due in part to the lack of space within the facility. For instance, the administrator informed PERD that the Fatality and Mortality Review Section has enough space for five staff, but the agency needs an additional five. Furthermore, the toxicology lab has need for a total of 12 full-time lab technicians, but due to lack of space in the lab, it can only employ five.

Like Agriculture and OLS, the Medical Examiner's Toxicology Laboratory is overcrowded. The lab employees six analysts who are crowded into two small offices. Furthermore, one lab technicians' workspace is in the middle of the lab while a second technician's workspace is on one of the bench spaces (see Figure 4 above). The lab also needs a second biological safety hood and additional work benches. The lack of bench space forces the agency to store equipment in the hoods to free up space on the benches. The technicians also coordinate their schedules to take turns using the available bench space because there is insufficient bench space for all of them to work at the same time.

The Medical Examiner suffers from several issues with its HVAC systems. The building's HVAC and its air handling system that maintain the negative air pressure flow in the autopsy suite are antiquated, and all five of the building's air conditioning units need major repairs to keep them operational. Even when operational, the air conditioning units cannot maintain temperatures adequately in many spaces, so the Medical Examiner runs freestanding air conditioning units in almost every section of the building.

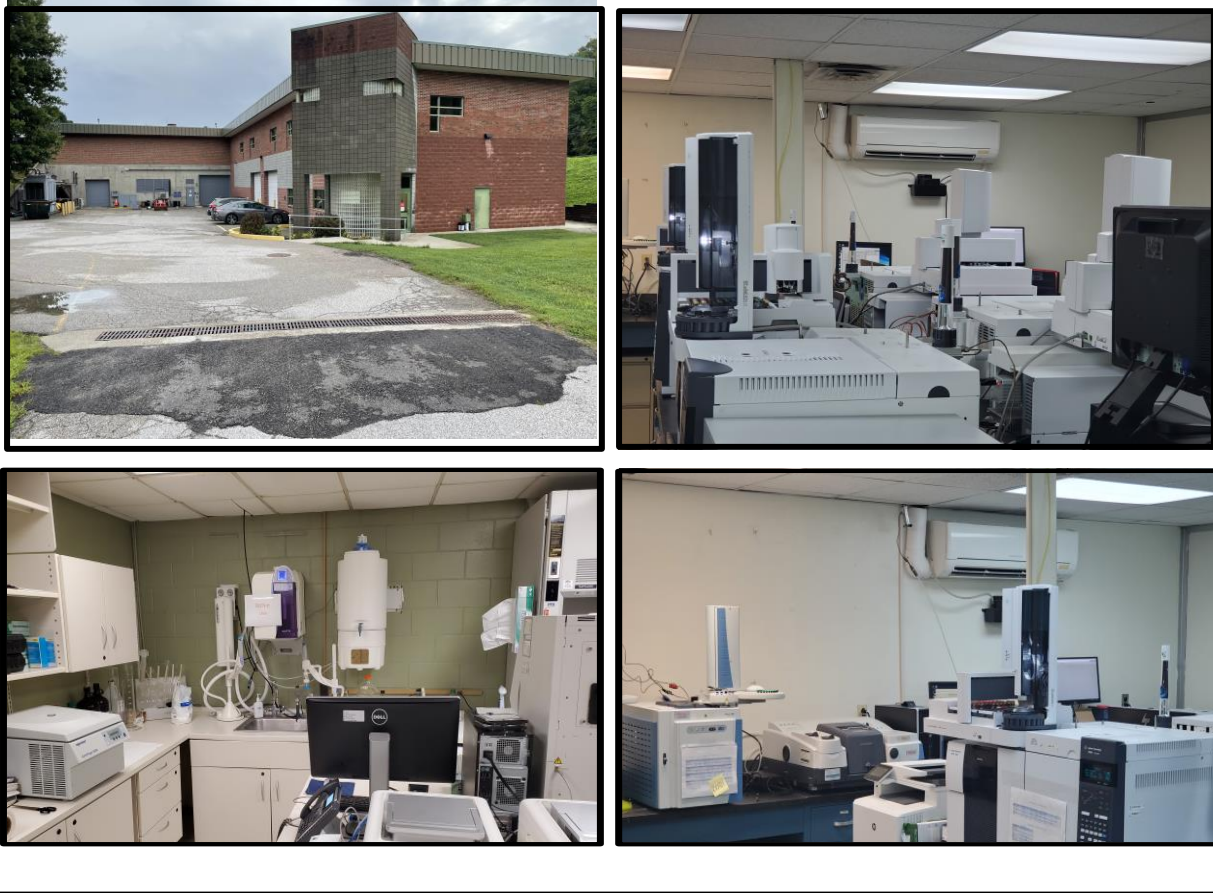
**Figure 5
West Virginia State Police Forensics
Laboratory Charleston, WV**

Figure 5 shows the facility and labs at the West Virginia State Police Forensic Laboratory. The State Police performs specialized examinations on evidence that is collected during criminal investigations. Services are provided free of charge to all law enforcement entities operating within the 55 counties of West Virginia. The laboratory is composed of seven specialized sections that provide the following services:

The State Police's Forensic Laboratory also does not have the ability to control the air temperature in individual labs, and the types of tests the machinery conducts in many of its labs require specific ambient temperatures to operate. Temperature control was noted as an issue in the DNA, Seized Drugs, and Toxicology labs, and like the other three agencies already discussed, the Forensic Lab is using stand-alone air conditioning units in these spaces.

The building also sits adjacent to railroad tracks that create issues with coal dust and vibrations. Some of the equipment in this lab is also highly sensitive to vibrations, so if a train goes by, the tests in this equipment must be shut down until the train passes. The technicians who maintain the testing equipment noted black dust inside the machines and the source is suspected to be coal dust from passing trains. As far as the agency knows, the dust has not impacted the tests conducted in this lab.

Year Built:	1970	Lab-purposed?	No
Secure Perimeter?	Yes	Adequate Space?	No
Testing Programs:	Seized Drugs, Toxicology, Trace Evidence, Biology/Processing, Biology/DNA and Databasing, Latent Prints, and Firearm/Toolmark

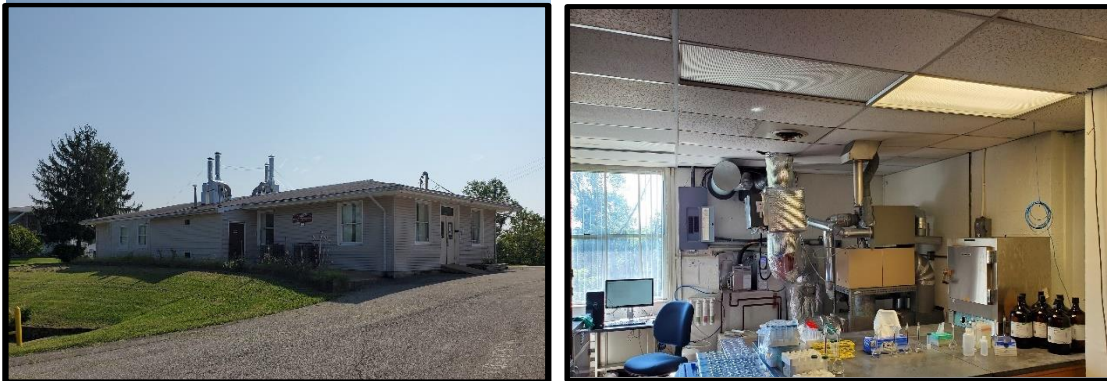
Figure 6
Department of Environmental Protection’s Air Quality Laboratory
Guthrie, WV

Age of Buildings:	1951	Lab-purposed?	No
Secure Perimeter?	Yes	Adequate Space?	Yes
Testing Programs:	PM 2.5 filter analysis and air toxics metals analysis

The only issues reported by the staff of the DEP lab were the need for a back-up power supply and the building not being lab purposed. The DEP lab is one of a few buildings at Guthrie that does not have a back-up generator. The building required significant retrofitting to add the required HVAC components to make the sample prep room into a “clean room.” (see Figure 6 above).

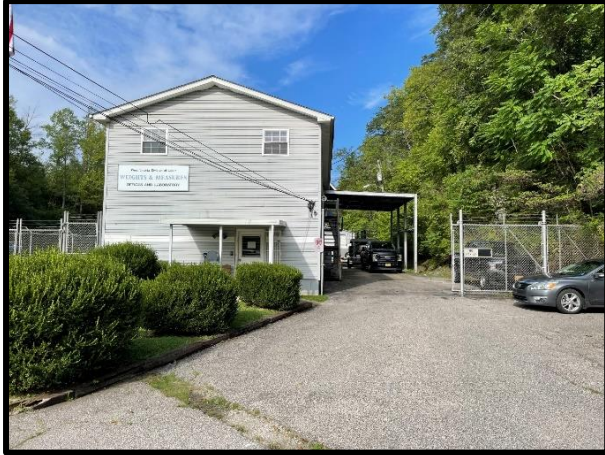
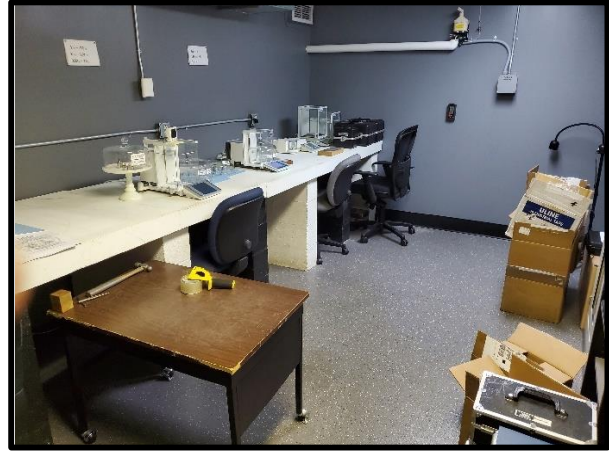
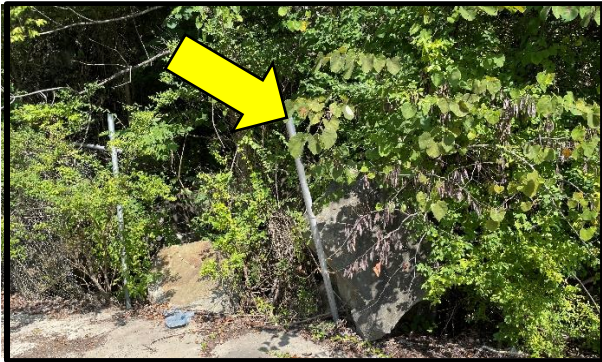
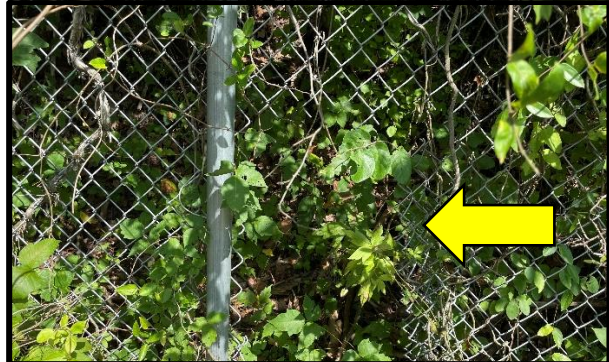
Figure 7
Division of Labor’s State Measurement Laboratory
St. Albans, WV

The West Virginia State Measurement Laboratory, within the Division of Labor, houses the state standards of mass and volume. Standards are used to ensure that scales and provers used in commerce are accurate. This laboratory also maintains measurement traceability to the National Standards in Gaithersburg, Maryland. The agency employs certified metrologists who calibrate the weighing and measuring standards. The building that houses the Division’s offices and laboratories was purchased by the Division of Highways in the 1970s. It originally contained offices and a garage. An addition was constructed to the back of the original structure sometime between the 1970s and 1990s.

Decade Built:	1970s	Lab-purposed?	No
Secure Perimeter?	No	Adequate Space?	No
Testing Programs:	Small Mass, Small Volume, Intermediate Mass and Volume, and Large Mass and Volume

Security was the most significant issue noted by the lab’s director. For instance, the director stated that someone once rammed the gate surrounding the backside of the building and stole a utility trailer off the lot. He also showed PERD staff holes in the buildings perimeter fence that had been cut by trespassers trying to break into the facility. It should also be noted that rocks have slipped from the adjacent hillside and damaged sections of the fencing. While not necessarily a criminal issue, falling rocks are a threat to both people and equipment on the property (see Figure 7 above).

In 2015, the Weights and Measures building was renovated after the Division's accrediting body, the National Institute of Standards and Technology, threatened to withdraw the division's accreditation unless upgrades were made to the facility. The facility was updated, and the Division maintained its accreditation to date. These updates included rubber floors to improve insulation, and independent temperature and humidity controls for the Small-Mass Lab. The National Institute of Standards and Technology grandfathered the Division from complying with certain requirements under the accreditation standards, but if the agency is moved, the facility must meet the current standards. This included having the Small-Mass Lab built on an independent foundation and installing marble bench tops in the lab to help reduce vibrations. Furthermore, the Large Mass and Large Volume is currently grandfathered for the environmental conditions due to the cost of controlling such a large space but would be required to meet the specifications in a new lab. The Weights and Measures lab also did not have a back-up generator for its facility but had bids out for two at the time of PERD's visit.

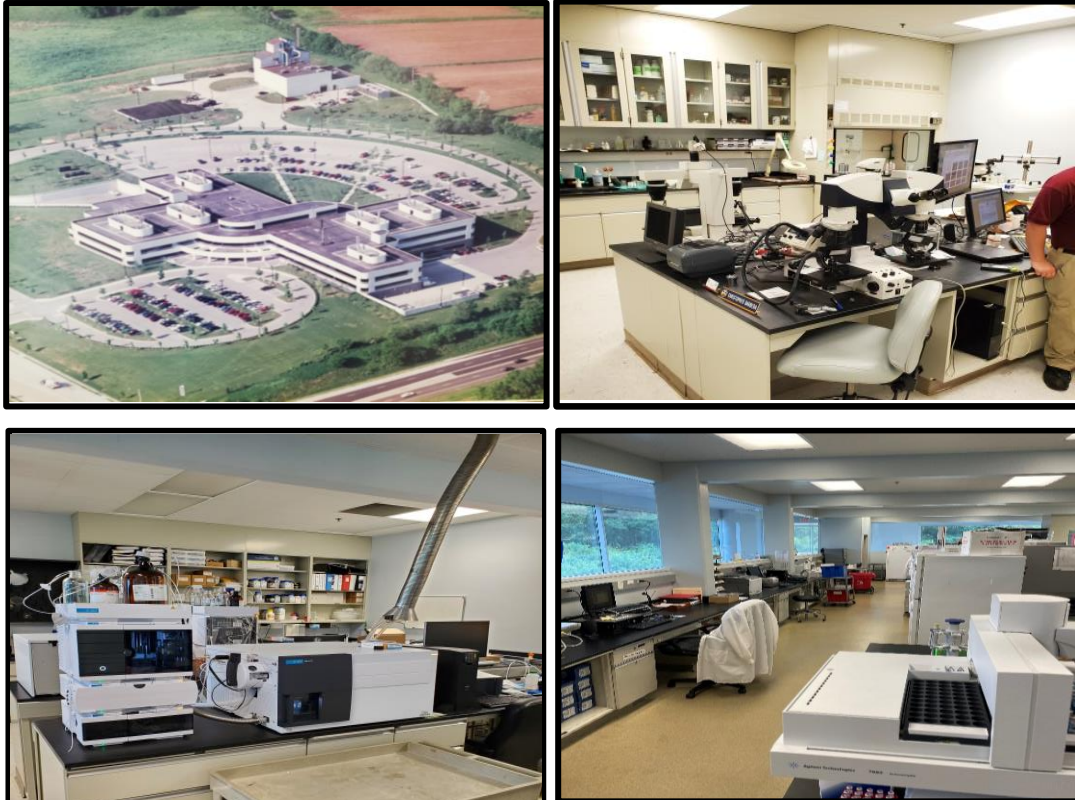
Figure 8
Kentucky State Centralized Laboratory
Facility Frankfort, KY

Kentucky dealt with a similar situation with its laboratories in the 1990s that West Virginia is currently facing. The Kentucky Centralized Laboratory Facility is a state facility that houses laboratories for the State Police Forensic Services; the Department of Public Health's Division of Laboratory Services and the Radiation/Environmental Monitoring Section; the Department of Environmental Protection's Division of Environmental Program Support; and the Office of the Medical Examiner's Office (see Figure 8 below). Several agencies have additional laboratories around the state; however, the Consolidated Laboratory is the primary lab for each of the agencies listed above. Each agency's labs are in their own section (called "cores") of the building, although the State Police has one lab within the Laboratory Services core. The building is owned and managed by the Kentucky Finance and Administration Cabinet which leases space to the agencies located in the building. The facility was opened in 1994 at a cost of \$41,696,160 with 240,354 GSF of lab and office space. This facility provides an example of how a co-located laboratory could be set up and managed.

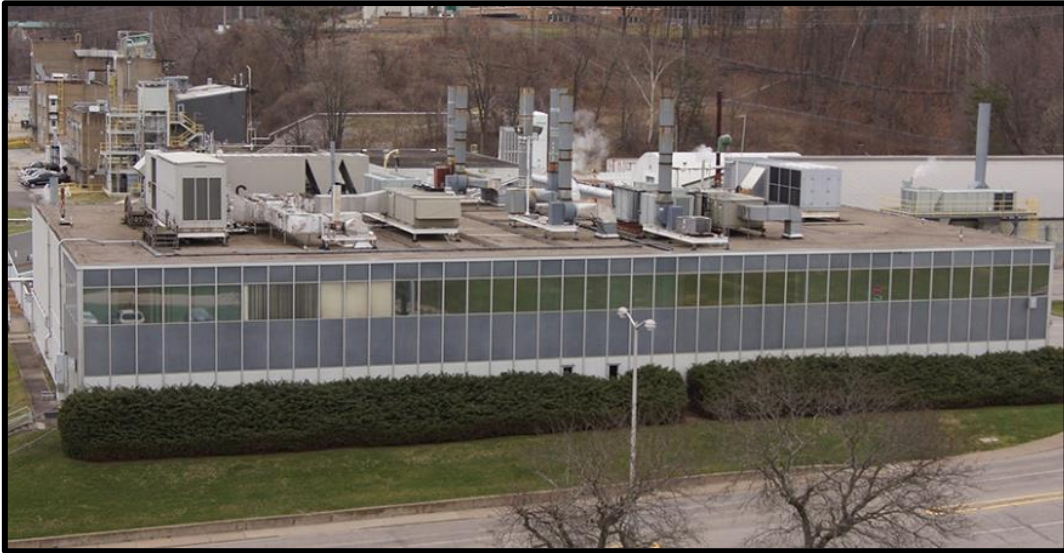
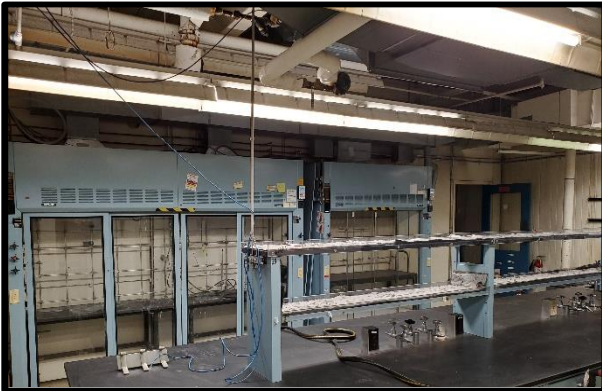
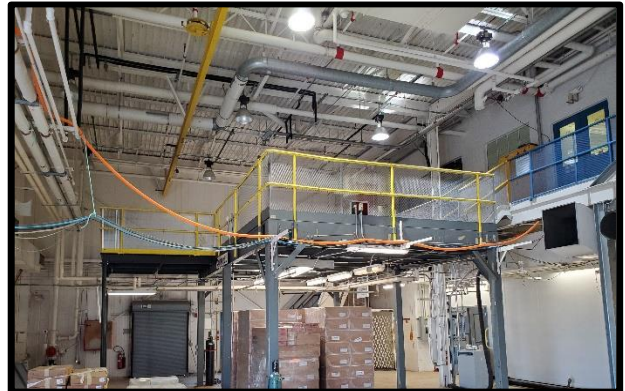
Figure 10
Building 727
West Virginia Regional Technology Park
South Charleston, WV

Figure 10 shows Building 727. It is entirely vacant and contains a total of 32,000 square feet in office and laboratory space. The building was constructed in 1965 and was used by Bayer as a research and development lab for new foam products until approximately 2013. It includes labs, offices, and a large loading dock with three bays on the first floor. Most of the labs have office space within the labs. This building also has a 18,000 square foot warehouse adjacent to it that is available. The building has been maintained since Bayer vacated the property, but it will require renovations prior to occupancy by a new tenant. According to the executive director of the Tech Park, renovating Building 727 will cost around \$15 million.

The interior of the building has been untouched since the previous owner vacated the property, but the Tech Park has begun the process of rehabilitating it. The Tech Park received a \$10,000 Brownfield Evaluation Grant from the United States Environmental Protection Agency to identify remediation, if present, of mold, asbestos (in the tile and insulation), and lead paint (on the handrails in the stairwells). The total cost for environmental remediation that was identified will cost less than \$90,000. It also needs three of its five HVAC units replaced. The building also needs a new roof. The building has a freight elevator but no passenger elevators. The Tech Park staff were unsure if the freight elevator needs replaced and need to have it inspected. It is also considering the addition of a passenger elevator. The hoods and benches also need to be replaced. The building only has one locker room, and the Tech Park plans to construct a second one. The building also does not currently have a reception area, which the Tech Park plans to add through remodeling the front of the building.

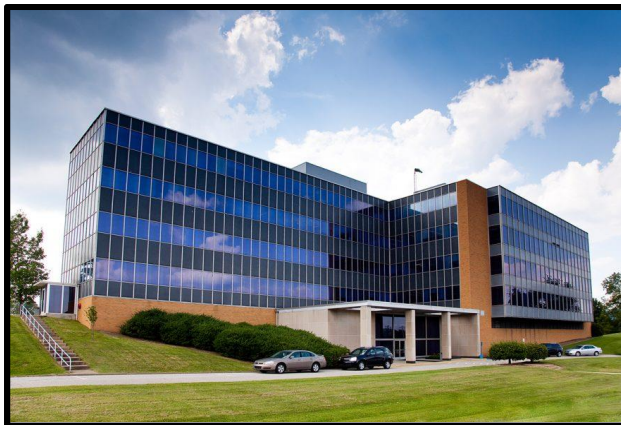
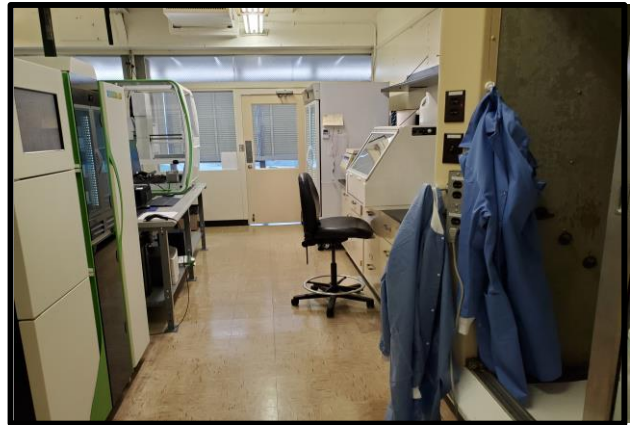
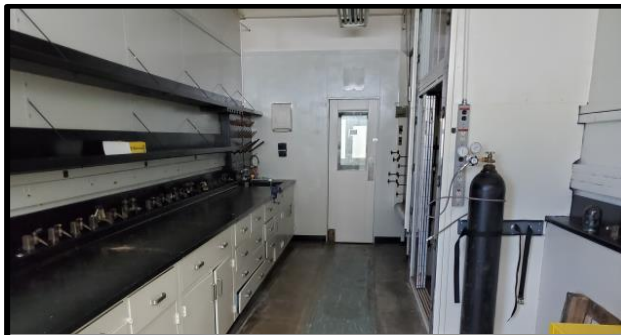
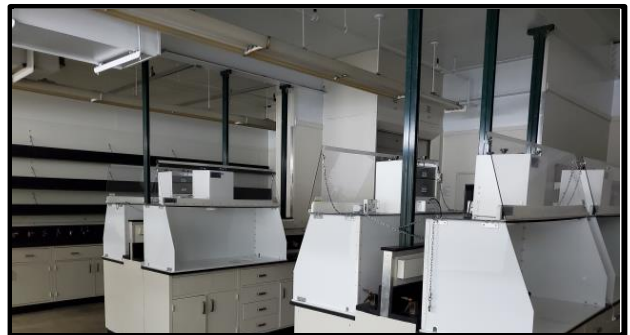
Figure 11
Building 740
Occupied and Vacant Lab Space
West Virginia Regional Technology Park
South Charleston, WV

Figure 11 shows Building 740 and some of its labs. This building has tenants, one of which is the Department of Health and Human Resources' Newborn Screening Testing Laboratory. The

picture at the top right of Figure 11 is one of the Newborn Screening labs. However, Building 740 has approximately 18,000 square feet of available lab and office space on multiple floors. The two pictures at the bottom of Figure 11 show two vacant labs. The vacant lab and office spaces in Building 740 are move-in ready unless a tenant needs special modifications. This building also has a conference room on each floor.

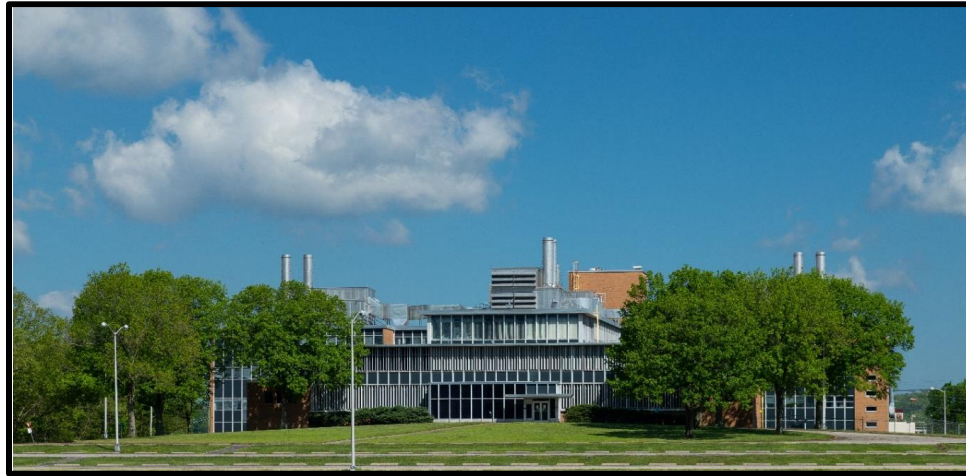
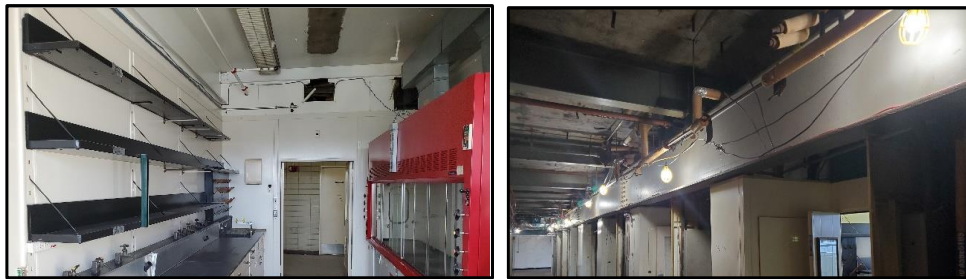
Figure 12
Building 770
West Virginia Regional Technology Park South
Charleston, WV

Building 770 can be seen in Figure 12. The building was built in 1958, it is four stories, and is entirely vacant with 132,000 square feet of which 120,000 is useable for office and lab space. According to the Tech Park's executive director, the building is about 60 percent lab space and 40 percent office space in its current layout; however, the ratio of lab to office space could be adjusted if agencies needed more lab space and less office space.

The building includes two passenger elevators in the middle of the building and a freight elevator in the rear. If multiple agencies were to move into this building, the elevators include key card readers that can be set to limit access to each floor only to those with authorized access. All the labs are under positive pressure. It also has a back-up generator.

Building 770 has been vacant for over a decade, but the Tech Park has invested in improvements to the building while seeking out a tenant for it. The Tech Park received \$11 million in federal and state funds to replace the HVAC and electrical systems around 2015. The funding included \$5.25 million in federal money, \$5.25 million from the State and again, the Park contributed a level of funding, that pushed the total spent to over \$11 million. The work completed included replacing the chillers, boilers, heat pumps, and air conditioning units. The fire suppression system has also been replaced. The main roof has also been replaced and the Tech Park plans to replace the façade on the outside of the building. The building has also been remediated for asbestos. Building 770 needs around \$60 million in additional work before tenants could move in. Some of the smaller roof sections, apart from the main roof, need to be replaced. The windows are

original, and the Tech Park plans to replace them all. The bathrooms on every floor need updated and refurbished.
