**Full Performance Evaluation**

**The Division of  
Culture and History**

**There is a Risk of Loss to the Archives and Museum  
Collections Due To Inadequate Storage  
and Insufficient Fire Protection**

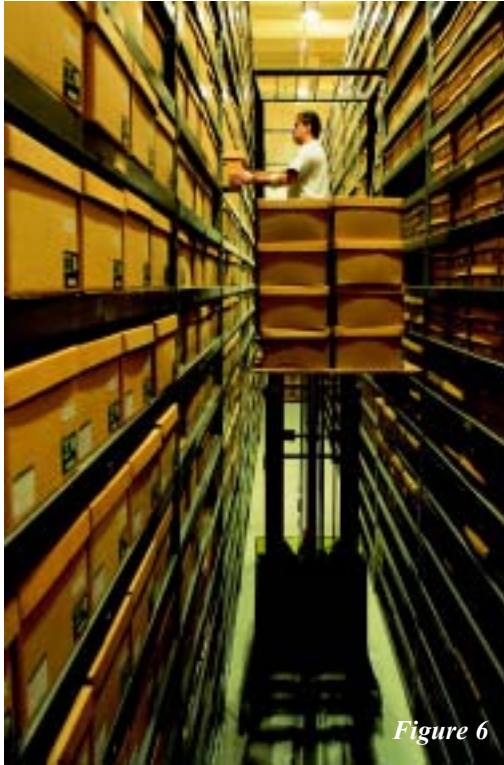
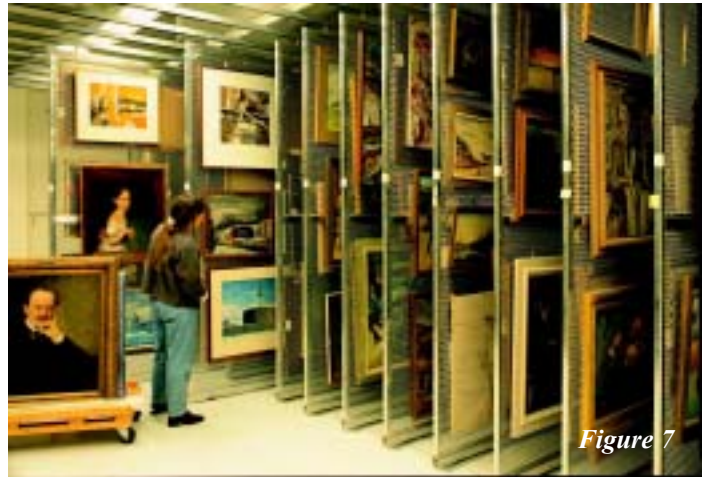
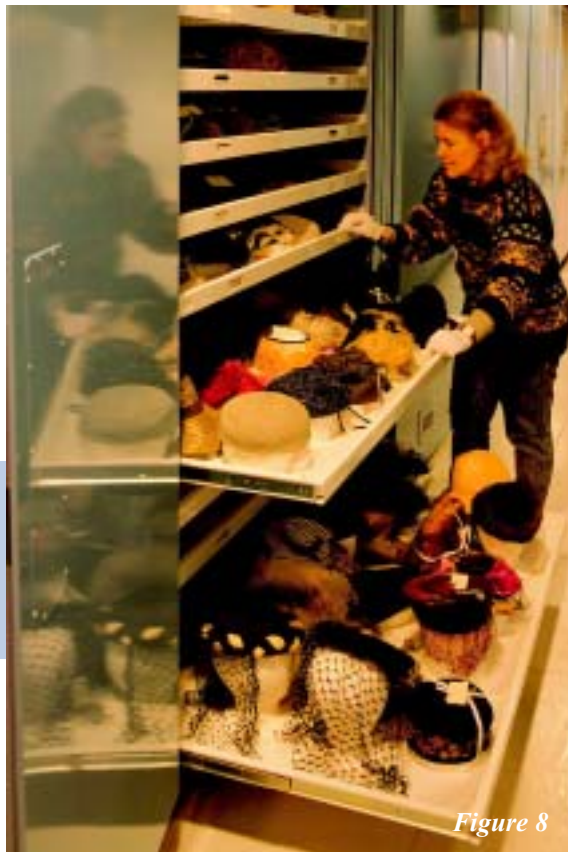
## Minnesota History Center

*Above Left: MHC Shelf Storage*

*Above: MHC Painting Storage Racks*

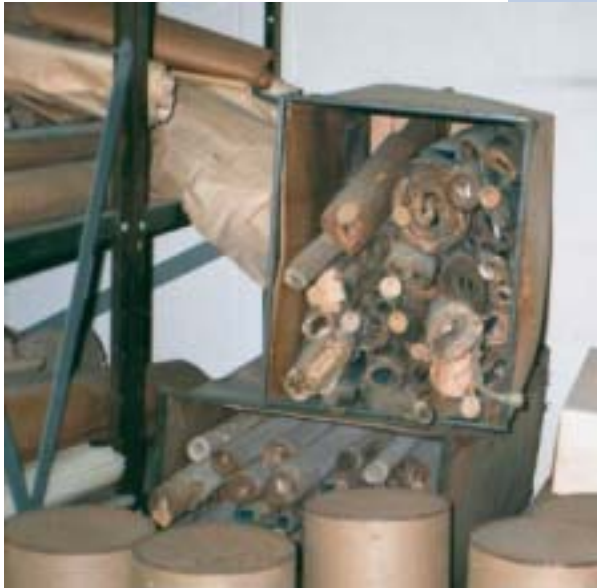
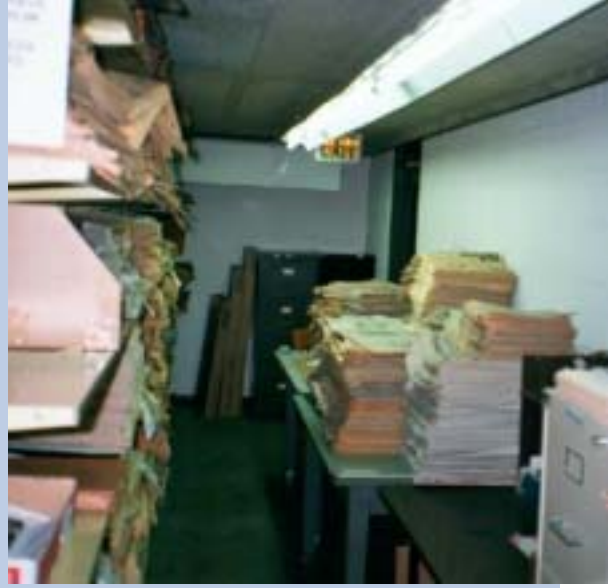
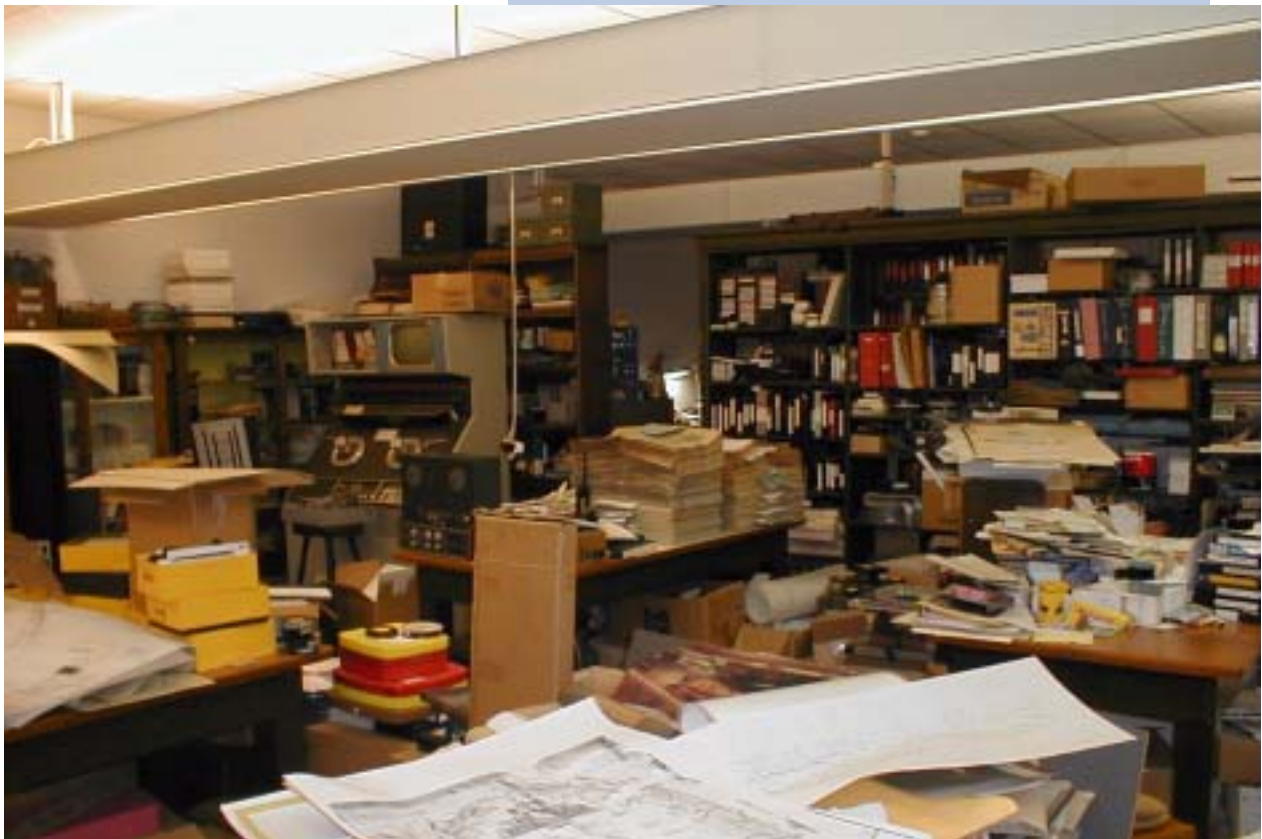
## Archives Storage Area & Graphics Processing

*The initial tours of the archives storage and work areas found cluttered, disorganized library stack areas housing archival materials with many non-archival items, such as old chairs and desks, antiquated and out-dated equipment.*

*Audit staff observed items that appeared to have mold or mildew on them located next to uninfected archival materials. According to national standards, archival materials infected with active mold or mildew should be isolated from other items and cleaned to prevent the spread of these conditions.*

According to national standards, archival materials infected with active mold or mildew should be isolated from other items and cleaned to prevent the spread of these conditions. A new HVAC system for the Cultural Center building now controls humidity. This has probably limited the active development of these conditions. However, should something happen to the HVAC system, these conditions could become active again and infect more archival materials. This problem should be assessed by an expert to determine if it is mold or mildew, whether it is of a type to be hazardous to human health, and if it is active. The materials should be properly cleaned. See photographs of the mold or mildew on books contained in the archives storage area on the preceding page.

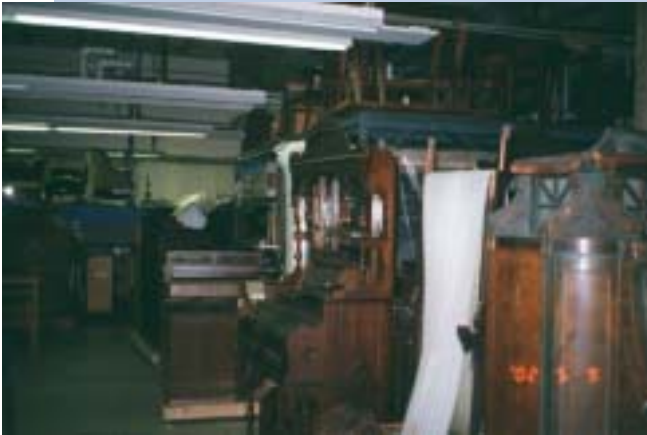
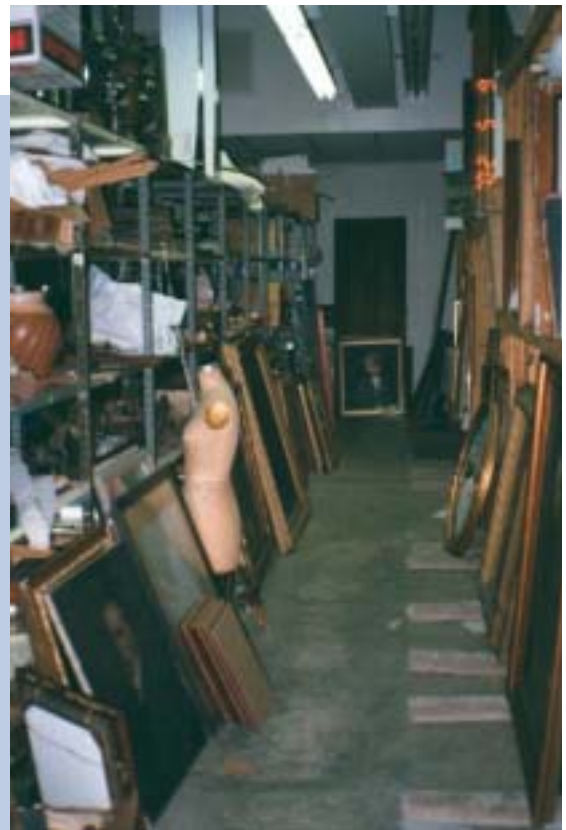
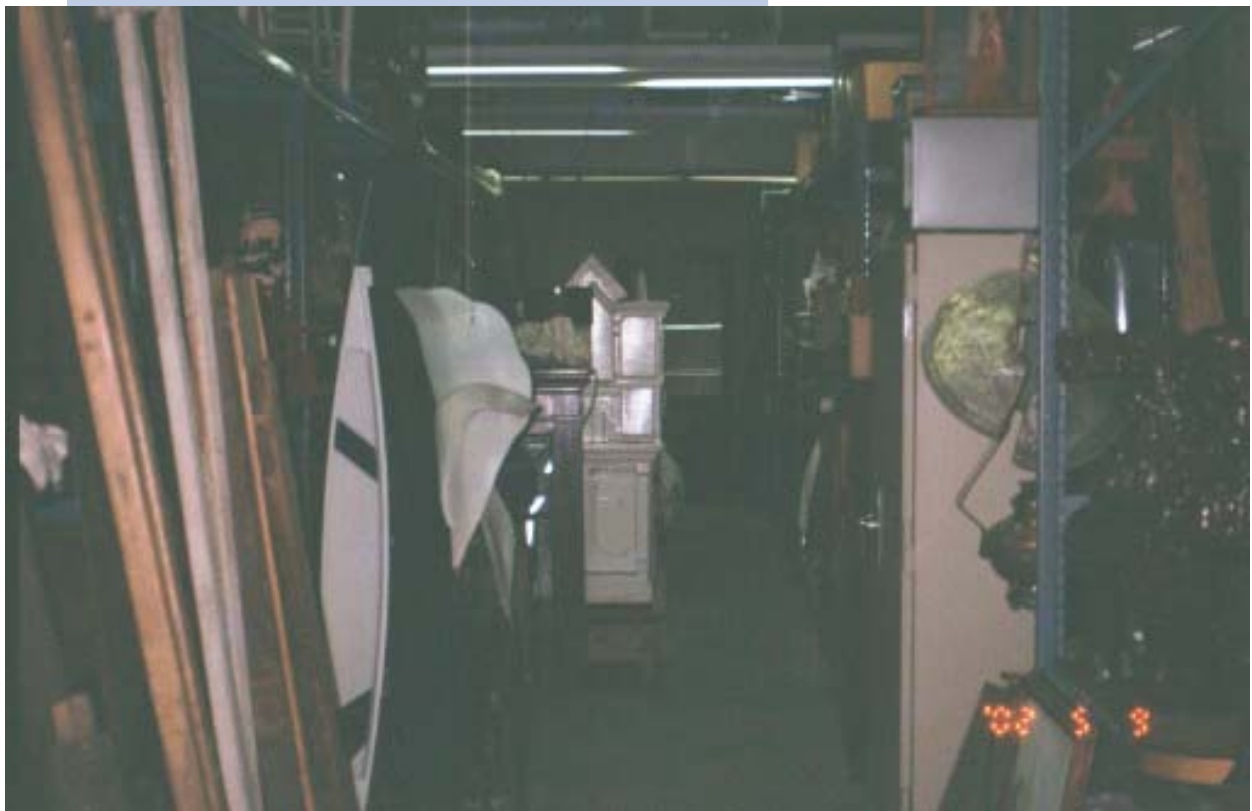
## Museum Storage Area

- i **Stacking.** Due to the cramped conditions, and lack of a professional space storage system, the staff is forced to store some artifacts by stacking, resulting in possible damage to items from friction, weight or

*Paintings and frames have also been damaged from the position of storage on wooden storage racks.*

possible breakage from falling. The storage areas also present safety hazards because walkways have items stacked on the floor. Staff carefully handle and place items in storage, but damage to artifacts could occur as staff attempt to navigate through the narrow areas. It is possible that artifacts could fall off the high, open shelves.

*The State Museum staff is aware of the problems with the current museum storage conditions. In its budget request for Fiscal Year 2002, the Division listed a need for a iMuseum industry standard condensed storage system to properly store collection items not on display.î*
